**Federal Aviation
Administration**

ADVISORY CIRCULAR

AVIATION MAINTENANCE ALERTS

**ALERT
NUMBER
374**

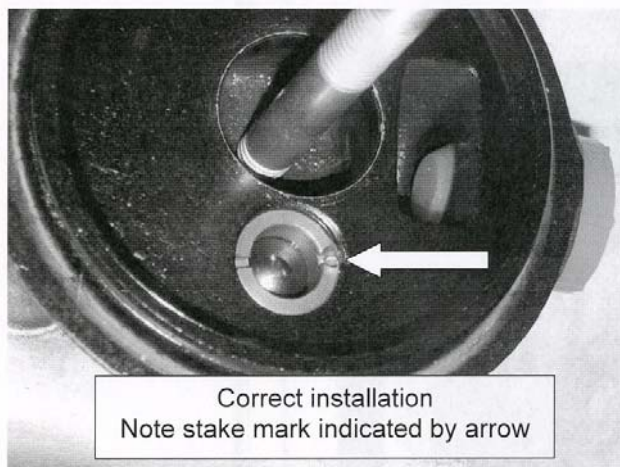
Correct installation
Note stake mark indicated by arrow

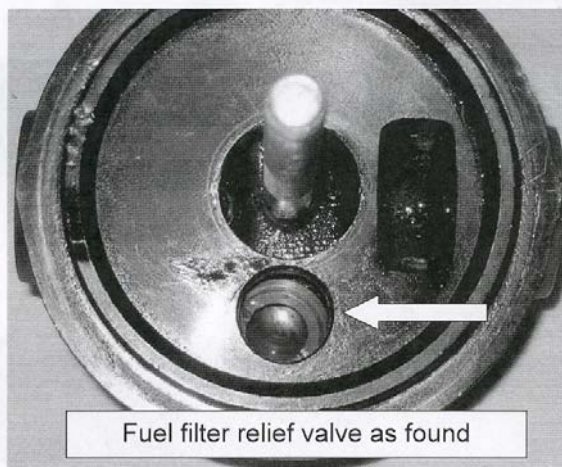
A technician writes, "During a scheduled phase inspection, *(we)* found a relief valve backed out of the fuel filter (P/N 50-389110). This firewall mounted filter has a ball-and-spring type relief valve threaded into the filter housing (P/N 02W760-140). The mechanic found the valve seat and ball completely backed out and displaced into the housing, allowing fuel to constantly bypass the filter. *(This)* valve seat (P/N 02FC213) is normally secured into the filter housing by 'staking' the threads. This is the third filter assembly in eight months that we have found in this condition (unstaked and displaced) in our fleet of 60 (plus) aircraft. It is interesting to note the valve backed out upwards, against gravity and spring pressure. The relief valve was reinstalled and staked."

Fuel filter relief valve as found

View looking up at fuel filter housing

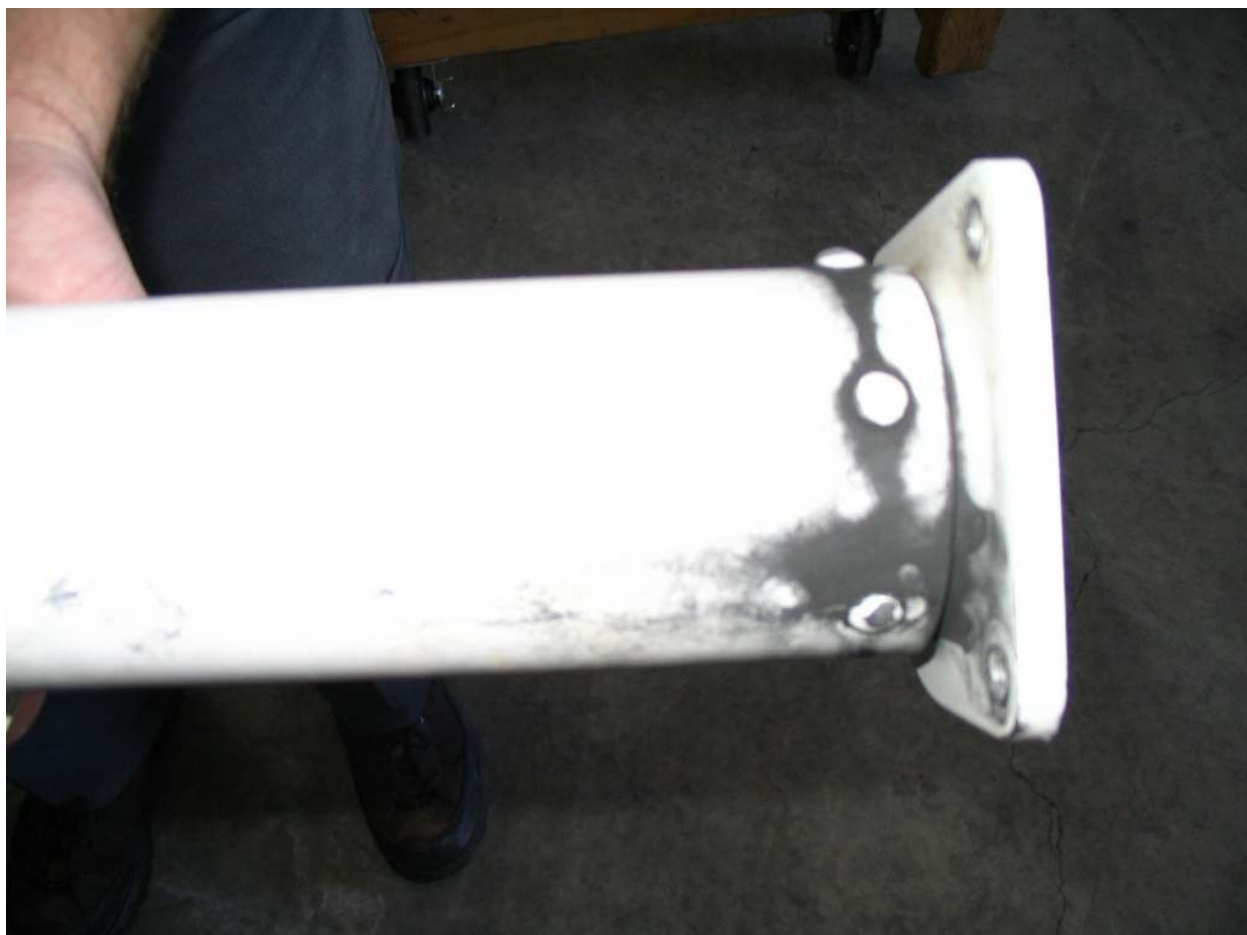
"Item Code 273001 states, 'Elevator—Inspect elevator skins for cracks and loose rivets; elevator hinges for condition, cracks, and security; and hinge bolts, hinge bearings, torque tube, horn, attach fittings, and bonding jumpers for evidence of damage or wear, failed fasteners, and security. Inspect elevator hinge bolts for proper safetying of nuts with cotter pins. Inspect balance weights for looseness and supporting structure for damage. Inspect outboard tips for cracks in rib flange'."

"This information is provided to remind operators and maintenance technicians to do the prescribed inspections of Chapter 5 of the Cessna maintenance manual with specific emphasis of Item Code Number 273001. This elevator inspection is required every 100 hours. Maintenance technicians are alerted to the maintenance concerning rivets that are common to the 2634017-1 Elevator Torque Tube Assembly and 26344017-2 flange.

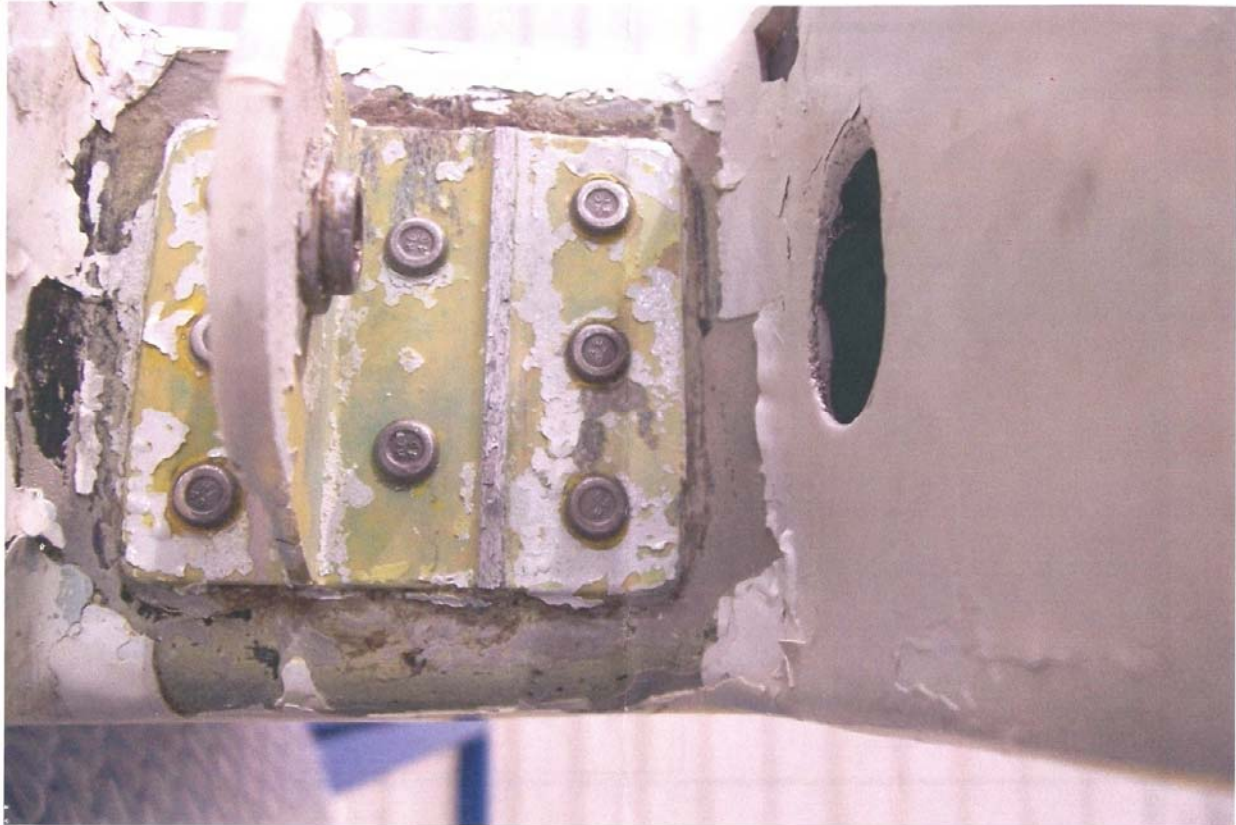
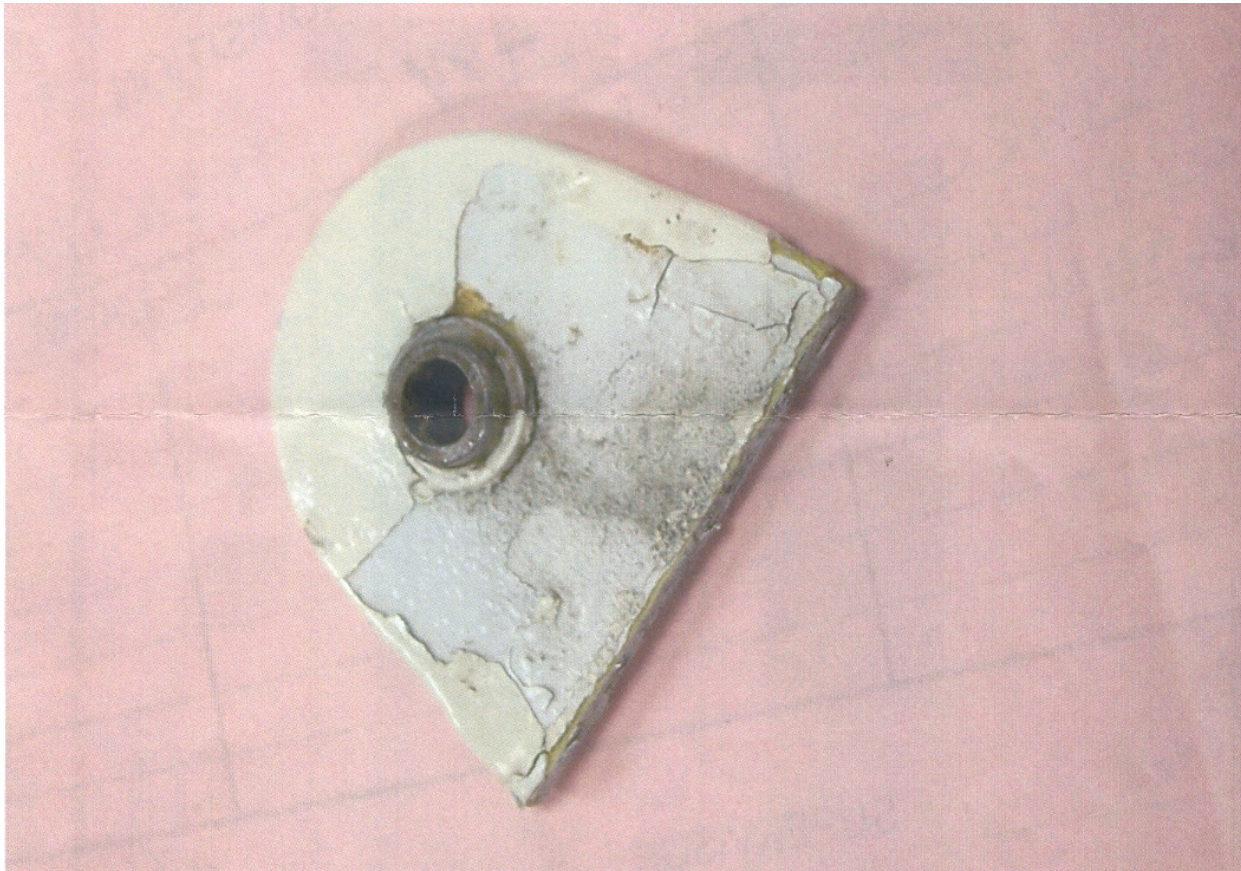
A repair station technician writes, "The left (*aileron*) outboard hinge bracket (*P/N 6590029-1*) broke off during aileron removal. It appears to have failed due to corrosion."

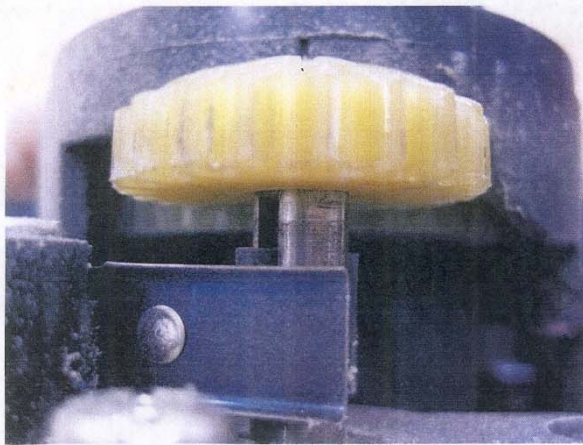
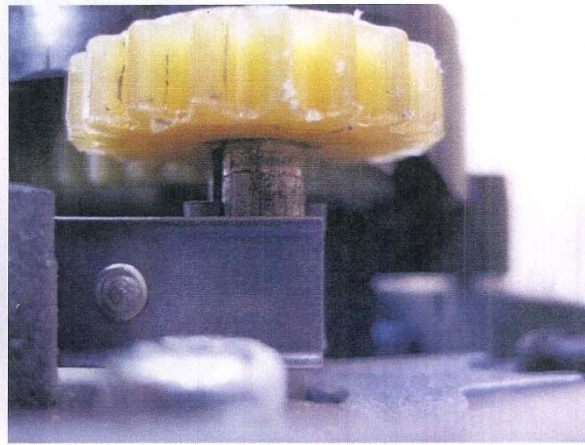
"The aircraft had intermittent magneto operation on the left magneto position during the ground run-up procedure. Aircraft maintenance was able to duplicate this problem, (*effecting*) removal of the magneto for internal inspection. Rotor (#16) was unseated from the rotor shaft, causing the lip on the rotor gear to be ground-up by the distributor block gear. The lip material was found throughout the inside of the magneto housing. Aircraft maintenance removed the right magneto for visual inspection and found the same damage as the left magneto. Both magnetos had factory torque seal applied to the top cover screws."

Rotor gears were found up on shaft

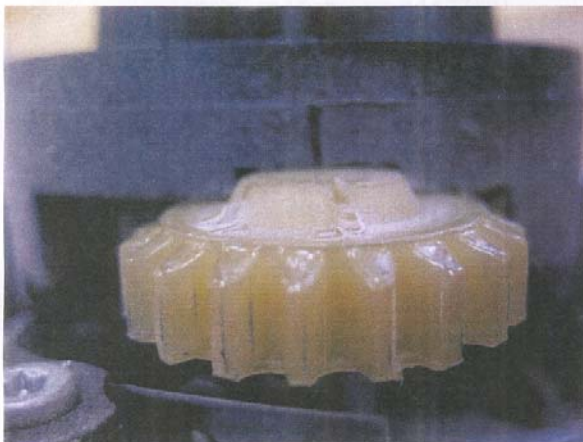
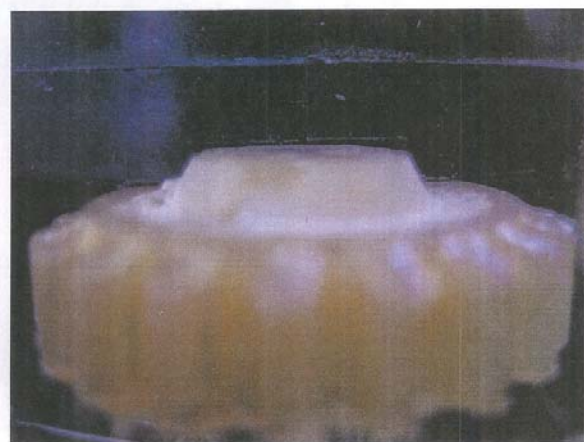
Rotor gears were found in contact with Distributor Block

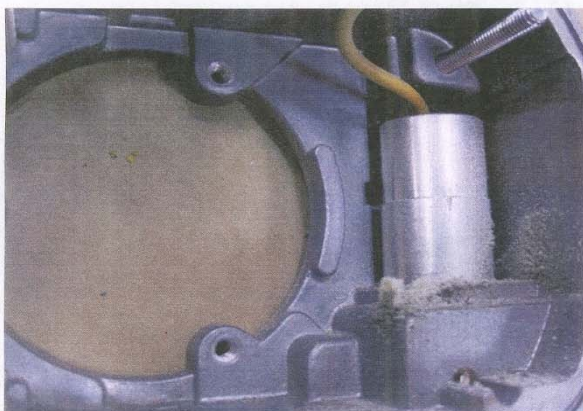
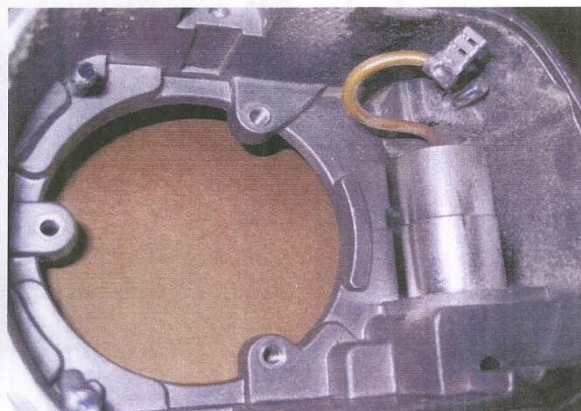
Rotor Gear material

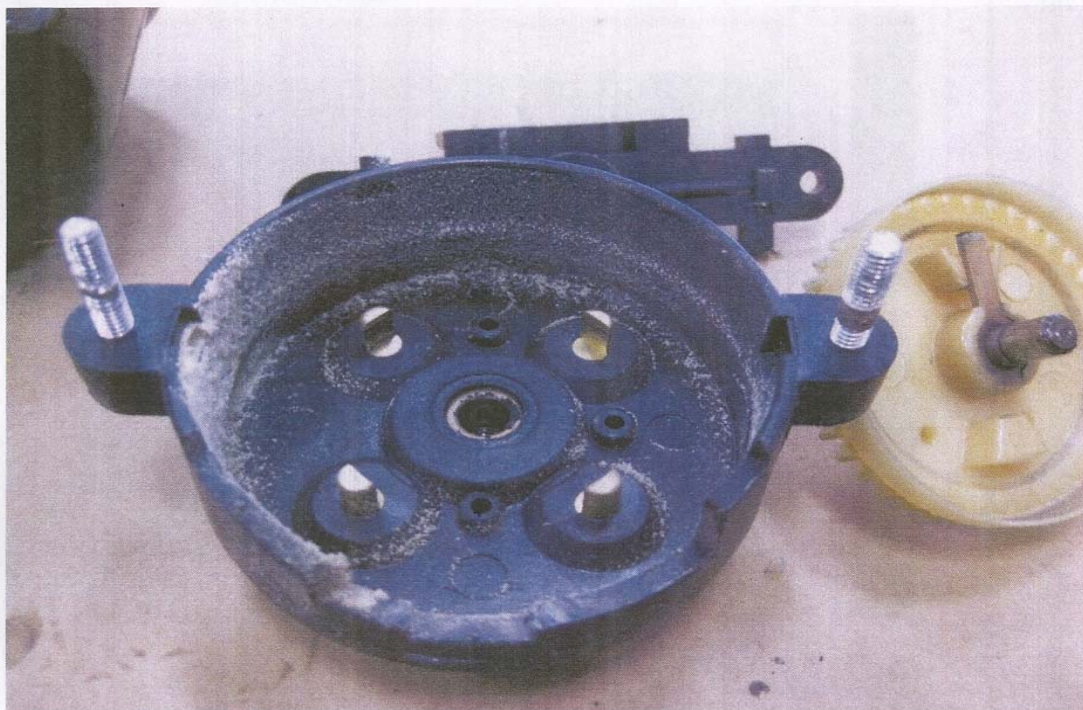
Rotor Gear Material

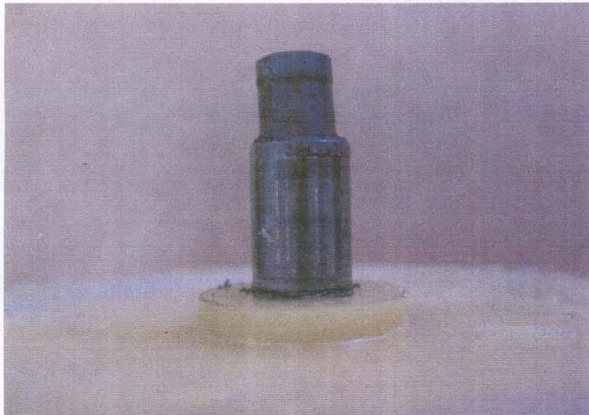
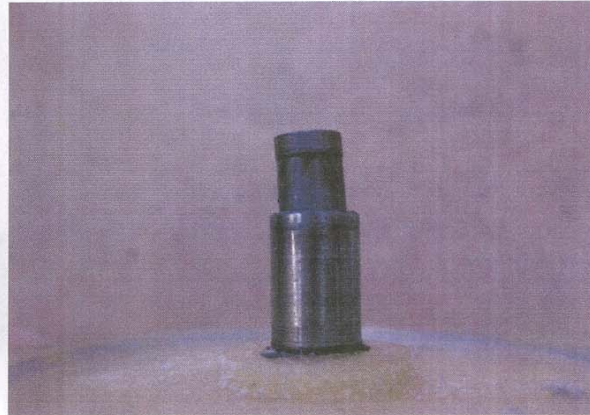
Carbon Brush (#27) Condition

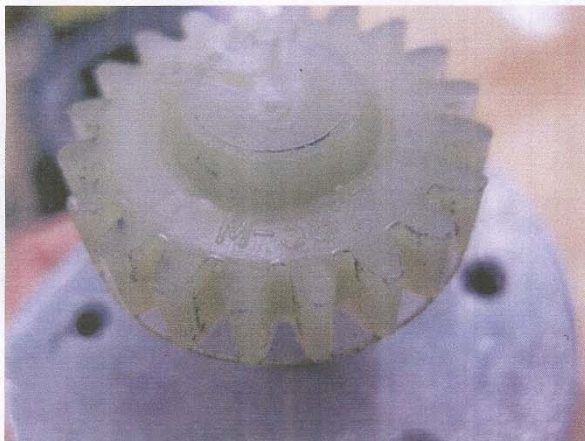
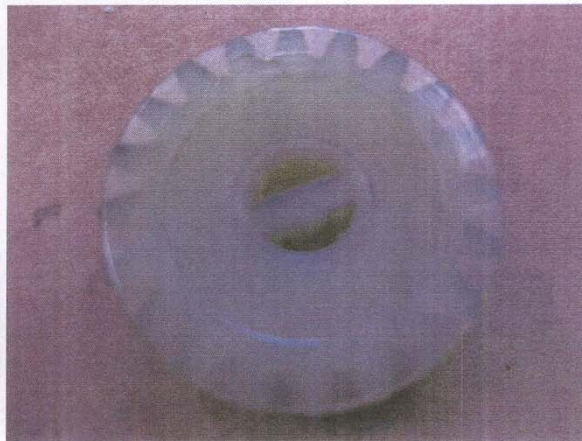
Serviceable Rotor Gear (M3827)
